# UNITED STATES COAST GUARD

## **MARINE SAFETY ALERT**

Safety Alert 13-18

### **Potential interference of VHF-FM Radio and AIS Reception.**

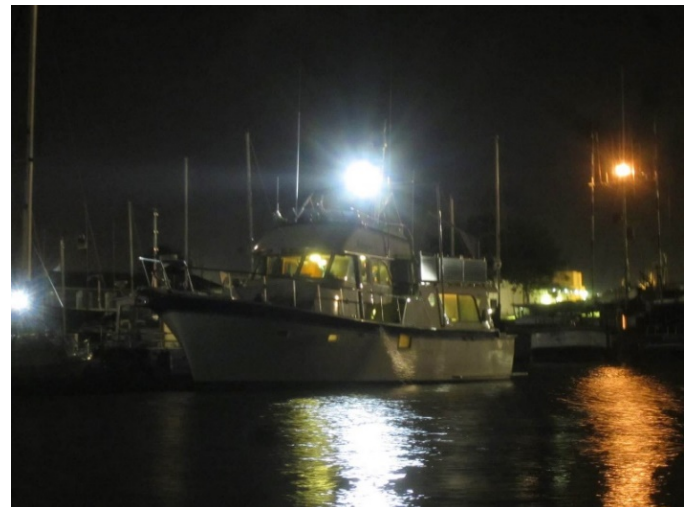
Radio frequency interference caused by these LED lamps were found to create potential safety hazards. For example, the maritime rescue coordination center in one port was unable to contact a ship involved in a traffic separation scheme incident by VHF radio. That ship also experienced very poor AIS reception. Other ships in different ports have experienced degradation of the VHF receivers, including AIS, caused by their LED navigation lights. LED lighting installed near VHF antennas has also shown to compound the reception.

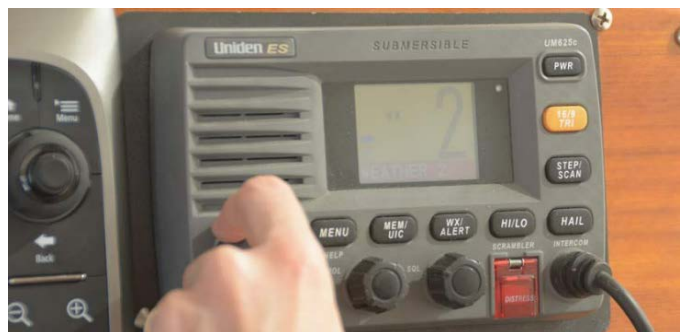
If the noise floor is found to have been raised, then it is likely that both shipboard VHF marine radio and AIS reception are being degraded by LED lighting.

1. Turn off LED light(s).
2. Tune the VHF radio to a quiet channel (e.g. Ch. 13).
3. Adjust the VHF radio's squelch control until the radio outputs audio noise.
4. Re-adjust the VHF radio's squelch control until the audio noise is quiet, only slightly above the noise threshold.

5. Turn on the LED light(s).
  - If the radio now outputs audio noise, then the LED lights have raised the noise floor. (Noise floor is generally the amount of interfering signals / static received beyond the specific signal or channel being monitored.)
6. If the radio does not output audio noise, then the LED lights have not raised the noise floor.
